SEISMIC RESIDUAL CAPACITY OF REINFORCED CONCRETE FRAMES

A thesis submitted in partial fulfilment of the requirements for the Degree
of Doctor of Philosophy in Earthquake Engineering
at the University of Canterbury
Christchurch, New Zealand
October 2018

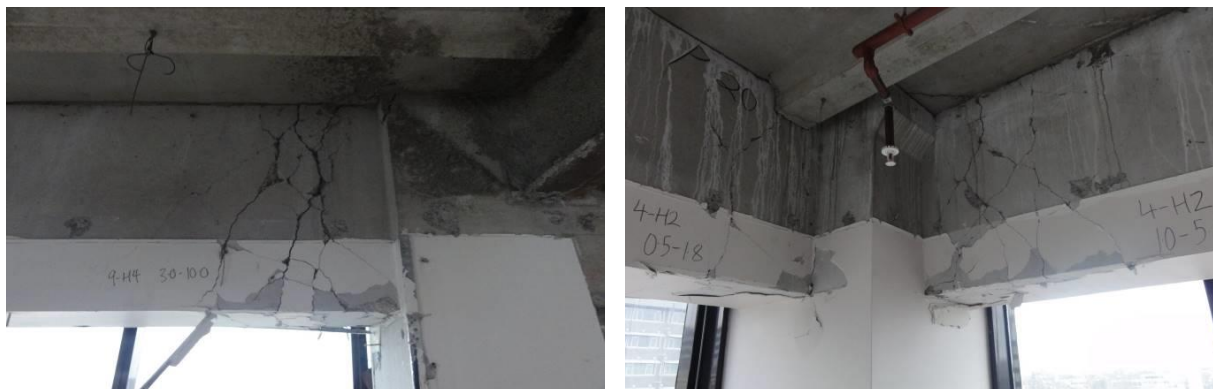
Figure 3-3. Typical damage observed in the superstructure of the PWC building, level 9 interior unit H4 (left) and level 4 corner unit H2 (courtesy of Stefano Pampanin, Fleishman et al, 2014).

It is noteworthy that most of the observed cracks were within, instead of outside, the plastic hinge relocation detail (see Figure 3-3) which thus apparently did not work as intended per the original design. Four H-frame specimens were extracted from the 16th floor level during the demolition process for experimental purposes (see Figure 3-4 and Figure 3-5).

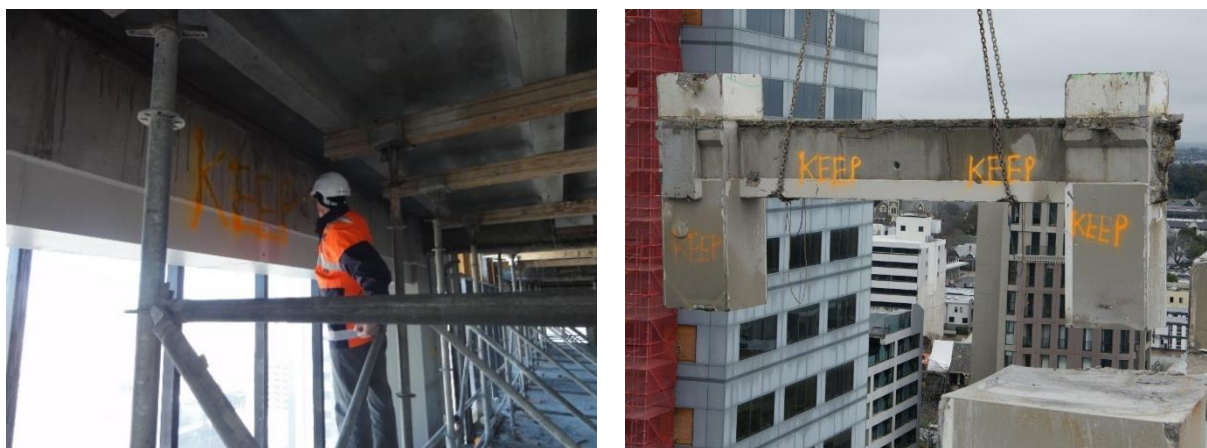
Figure 3-5. Specimens identification (left) and extraction (right) (photos courtesy of Stefano Pampanin).

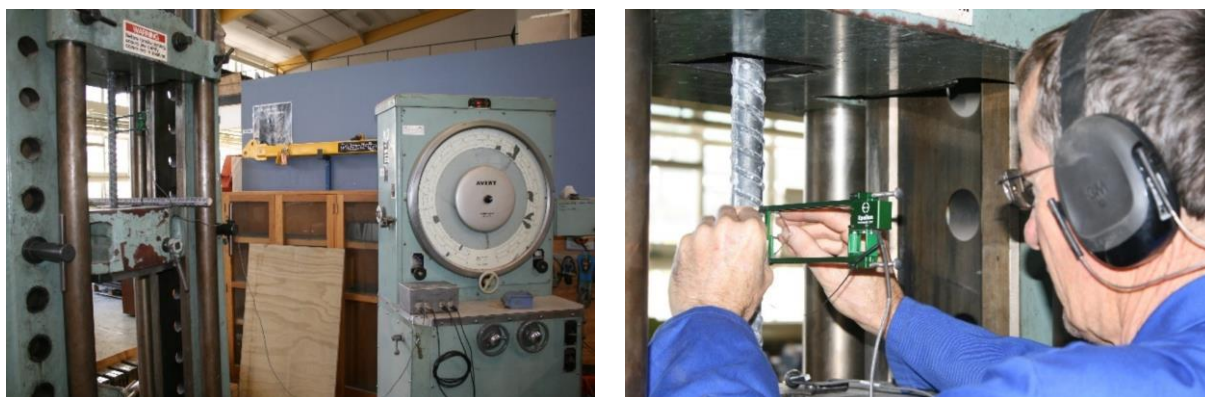
Figure 3-8. Uniaxial tensile test of deformed (unmachined) D28 bars, extracted at the mid-span of the beam.

Two samples of the longitudinal reinforcement were extracted from the mid-span of the beam, where less inelastic action is expected. The samples were subjected to a uniaxial tensile force as per the NZS3112:1986 (see Figure 3-8) to obtain their yield and ultimate strength and strain properties. Table 3-1 shows the results obtained using the nominal bar diameter.

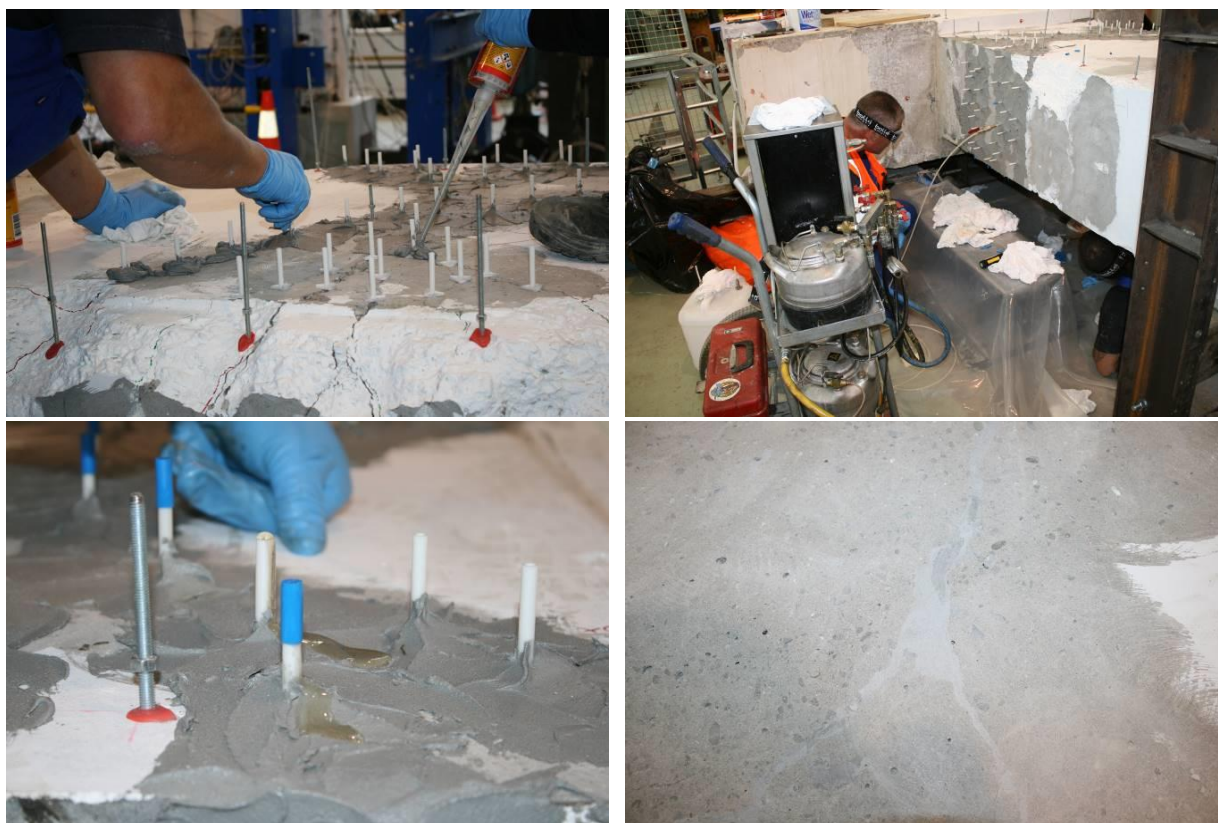
Figure 3-12. Sealing process with epoxy mortar and installation of injection ports (upper-left); resin injection with an air-operated pump (upper-right); epoxy resin leaking from and capping of the injection ports (lower-left); surface finish once the epoxy mortar has been removed (lower-right).

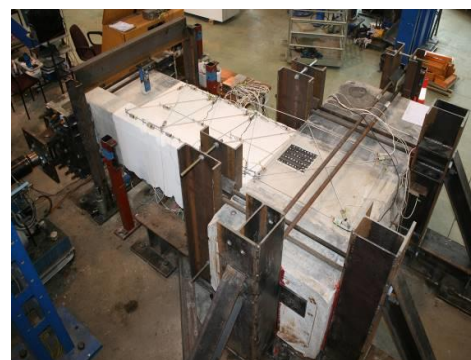
Figure 3-14. 3D CAD view of the reaction frame (left); specimen 1 during the tests (right).

As shown in Figure 3-13 and Figure 3-14, the reaction frame used for the tests consisted of steel braced frames anchored to the RC strong floor. The beam-column joint was placed horizontally on top of steel beams and clamped to the braced frames using steel channels and post-tensioned Macalloy bars. The beam-end was vertically supported on Teflon pads. A steel frame with a roller prevented the beam-end to uplift due to any accidental eccentricity that might occur at the actuator-to-beam connection.

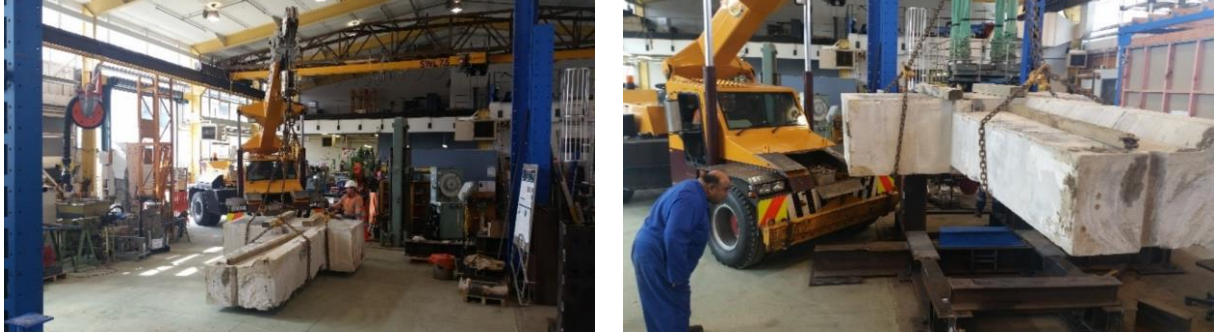
Figure 3-15. Placing of one of the specimens on the reaction frame with the help of a movable crane.

Due to crane capacities and restrictions in the laboratory, an articulated movable crane was required in order to place the specimen on the reaction frame (see Figure 3-15). A total of three beam column joints out of the eight extracted (i.e. four “H” frames) were tested during the experimental campaign.

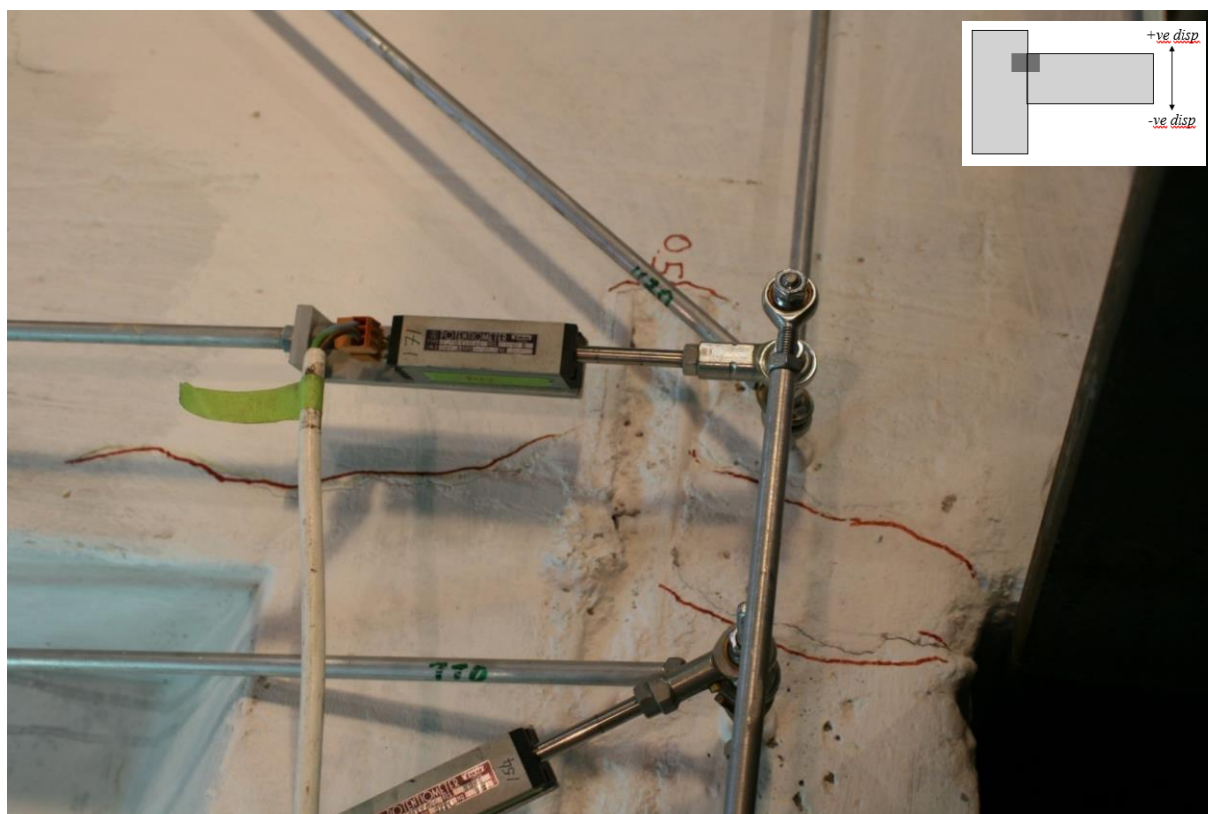
Figure 4-4. Initiation of diagonal crack at the socket location, Test 2.1.

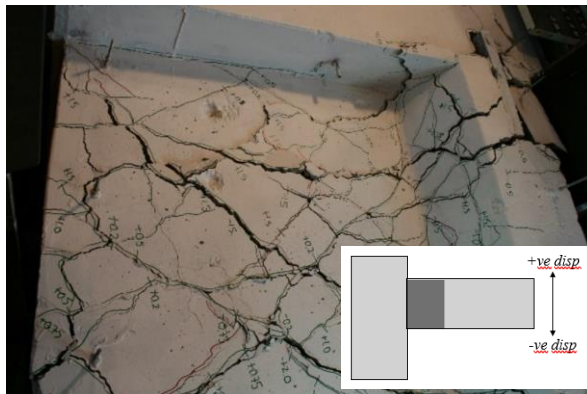
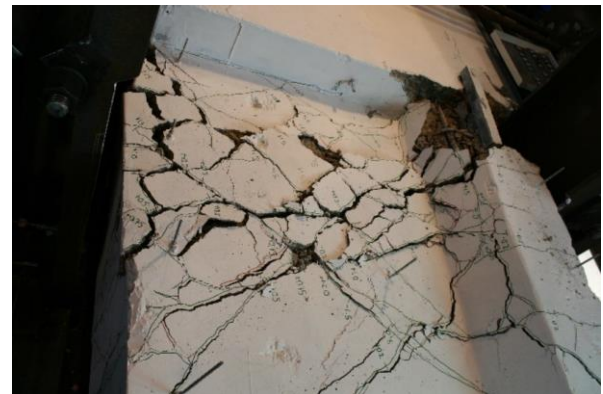
Figure 4-9. Cracked beam at 2.5% (left) and 3.5% (right) beam rotation.

Appendix C shows photographs taken during the epoxy repair process of specimen 2. Cracks 0.1 to 0.2 mm wide started developing at 0.1% “total” beam rotation (Figure 4-5). A new crack extended from the column face towards the interior of the joint and did not follow the injected crack path. At 0.75% “total” beam rotation, hairline cracks and cracks 0.1 mm wide started developing outside the plastic hinge relocation detail (see Figure 4-6). At beam rotations of 1.5%, residual (static) cracks started becoming comparable to the maximum observed (70-90% of the maximum crack width) (see Figure 4-7 and Figure 4-8). Maximum cracks 9 to 18 mm wide were observed at 2.5% “total” beam rotation (see Figure 4-9). As shown in Figure 4-10, most of the repaired cracks re-opened up during the Test 2.2.

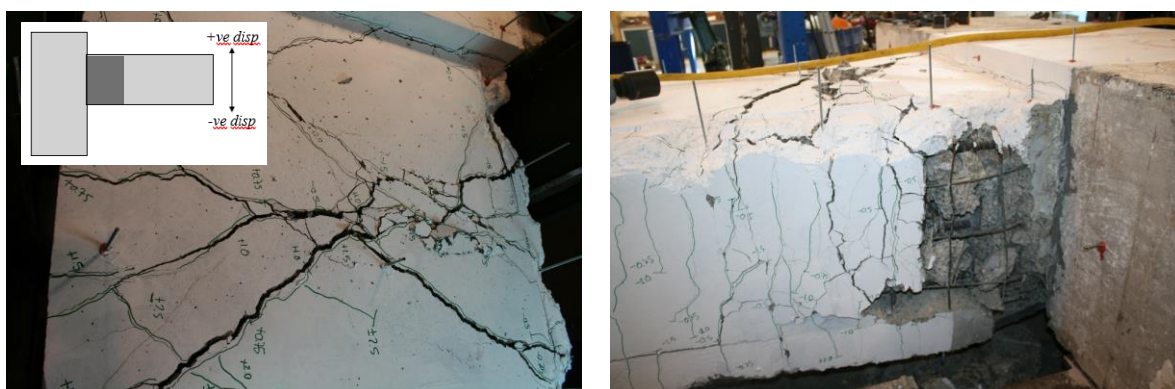
Figure 4-15. Cracked beam at 3.5% (left) and at 4.5% (right) beam rotation.

Maximum cracks of 10mm in width were observed at 2.5% beam rotation (see Figure 4-14). Figure 4-15 shows the cracking pattern at 3.5% and 4.5% “total” beam rotation level. Figure 4-16 shows a crack at 4.5% beam rotation with the epoxy that has penetrated during the repair works. As shown in Figure 4-17, most of the repaired cracks opened-up during the Test 3.2.

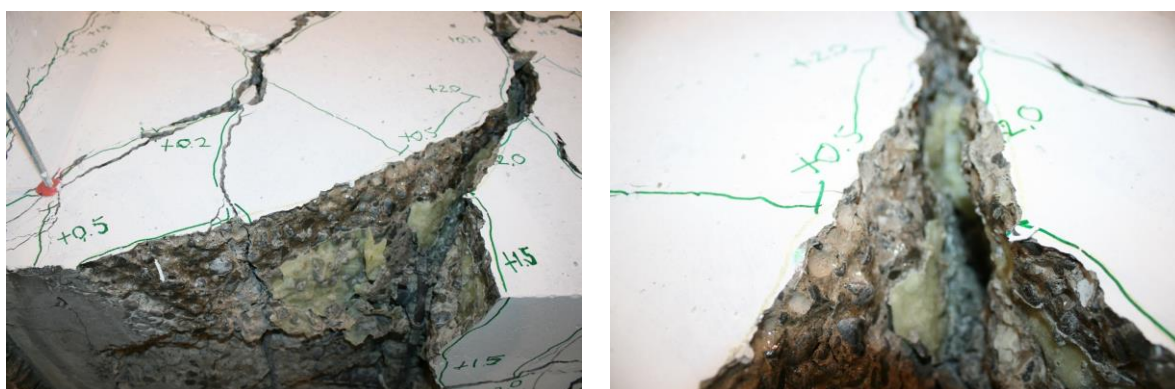
Figure 4-16. Crack opened-up at 4.5% beam rotation, showing the epoxy which has penetrated during the injection process.

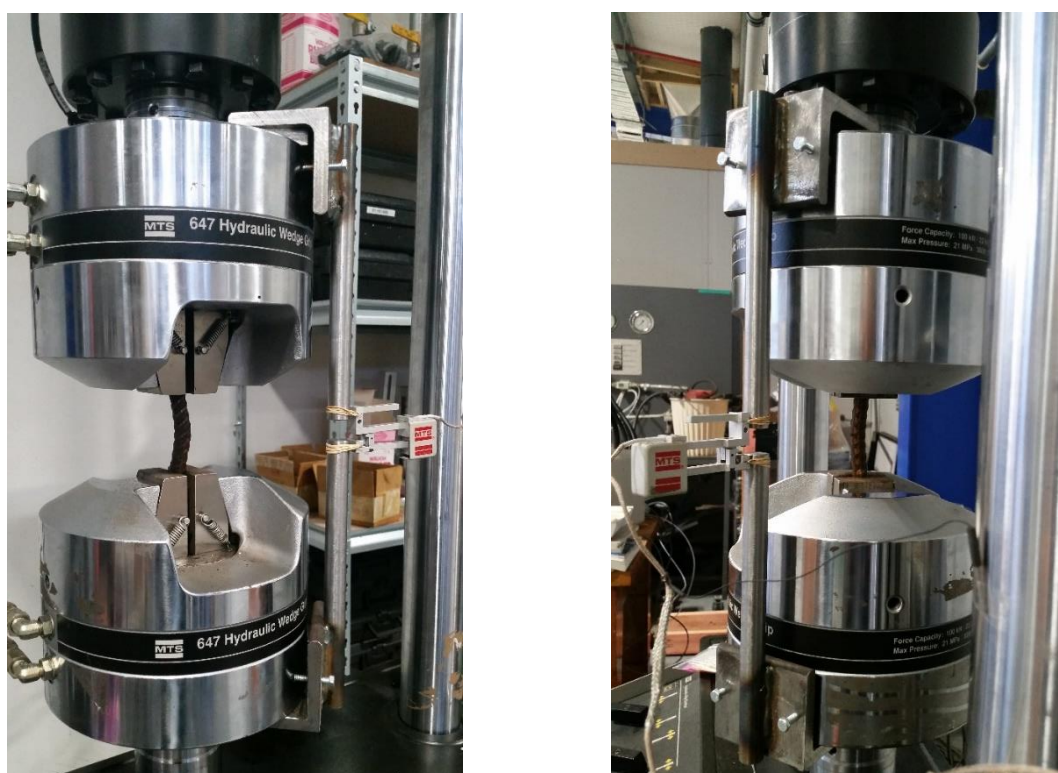
Figure 7-7. Test setup adopted for the cyclic and monotonic tests after the calibration process.

Two extensometers were initially installed to allow for a calibration process; one 25 mm gauge length extensometer was installed in the bar specimen (internal extensometer), and another one in the external device (external extensometer). The readings in the external extensometer were calibrated with the readings in the internal extensometer during monotonic tensile tests (see Loporcaro, 2017, for a detailed explanation of the calibration process). After the calibration, the external extensometer was used to perform the tests in the specimens without the need of the internal extensometer, thus avoiding stability problems and inaccuracies in the readings due to bar buckling (see Figure 7-7).

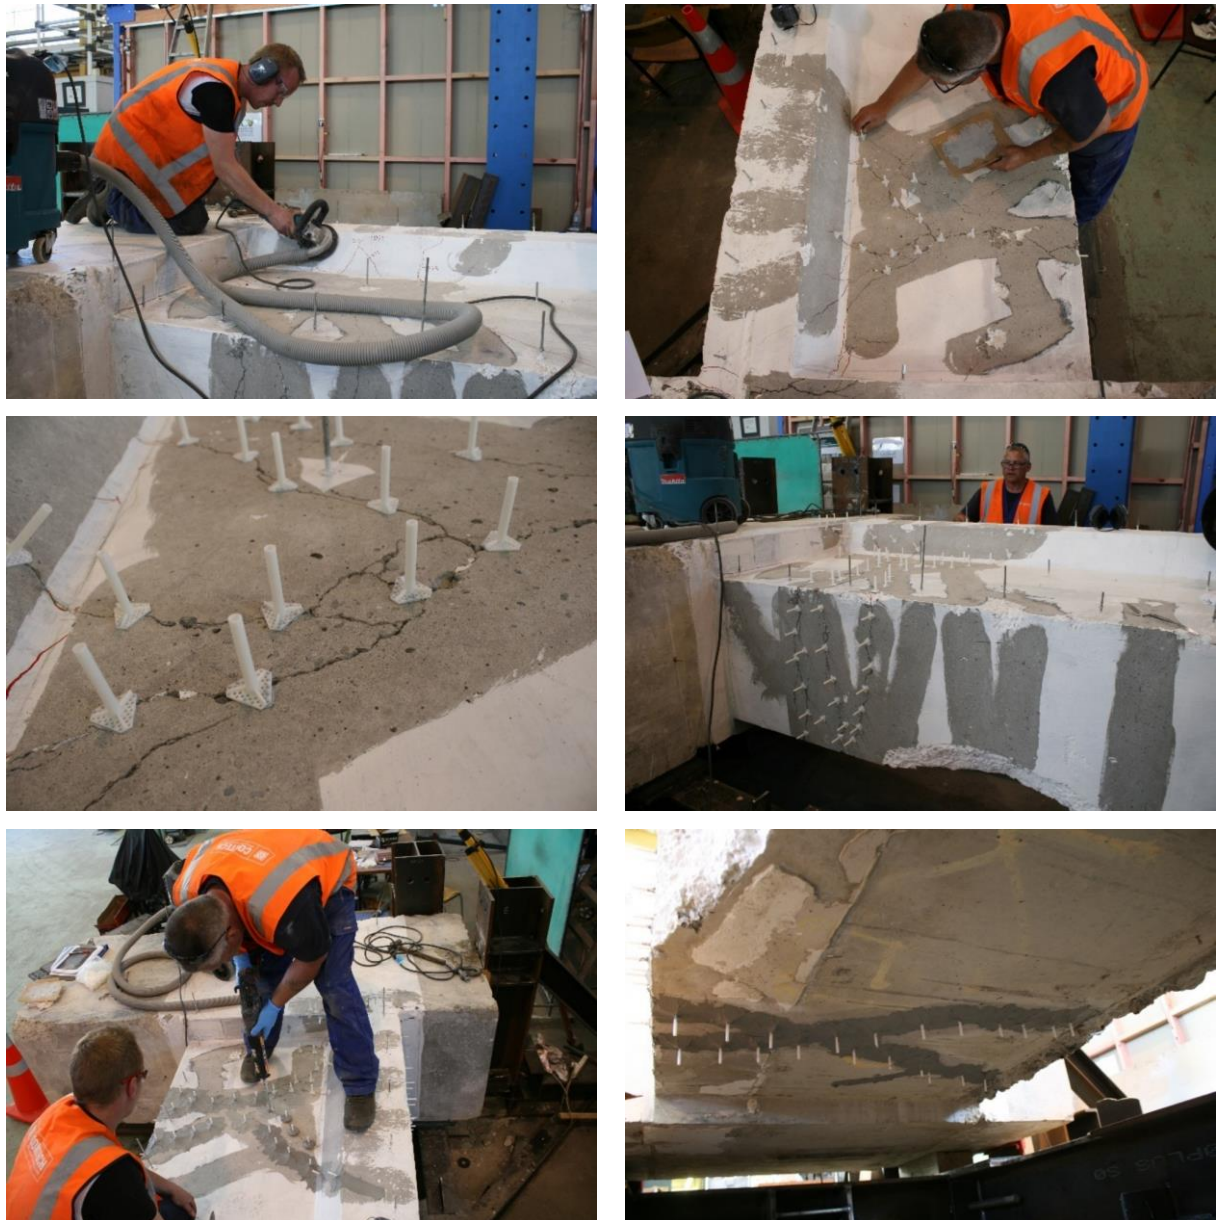
Figure C- 1. Sealing of the cracks before the epoxy injection, Test 2.

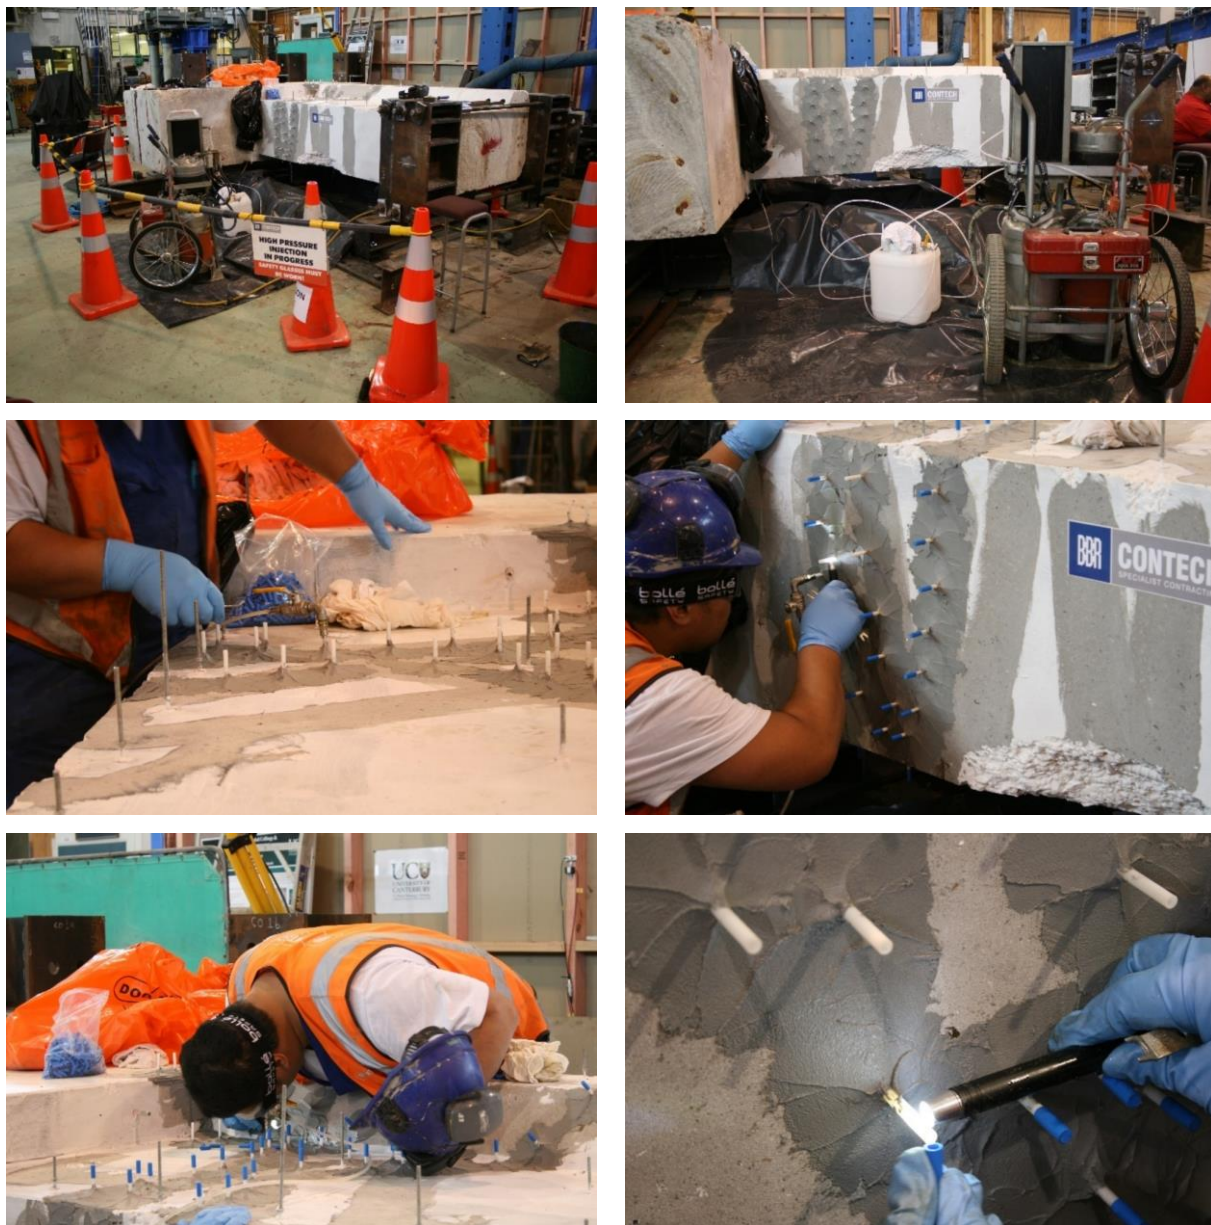
Figure C- 2. Epoxy crack injection process, Test 2.

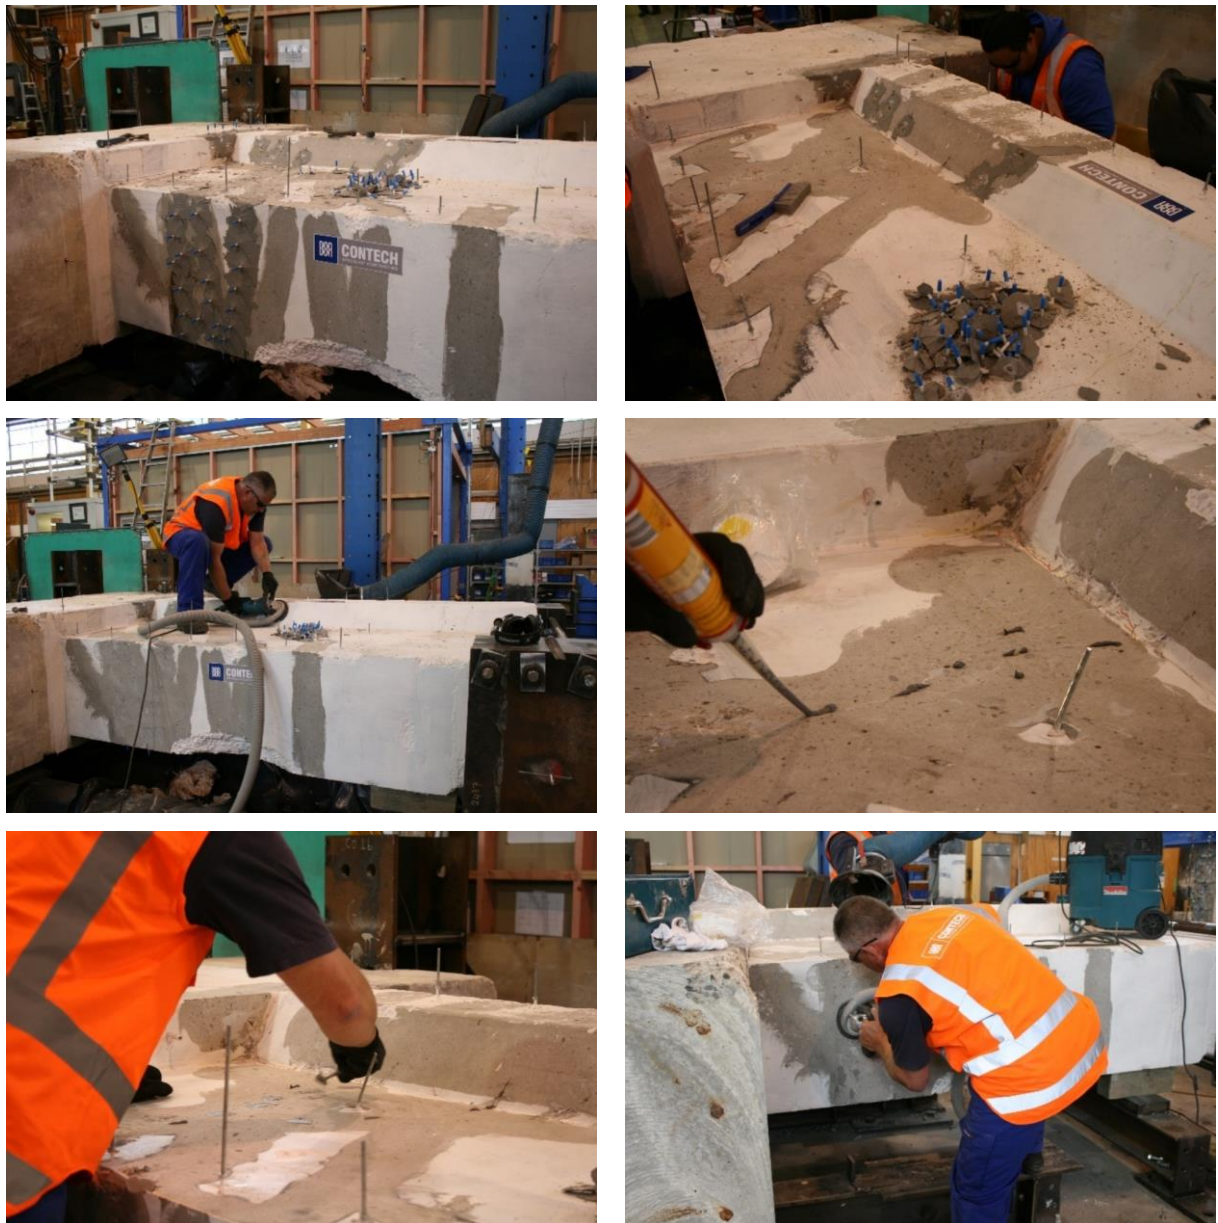
Figure C- 3. Cleaning process after the epoxy has cured, Test 2.

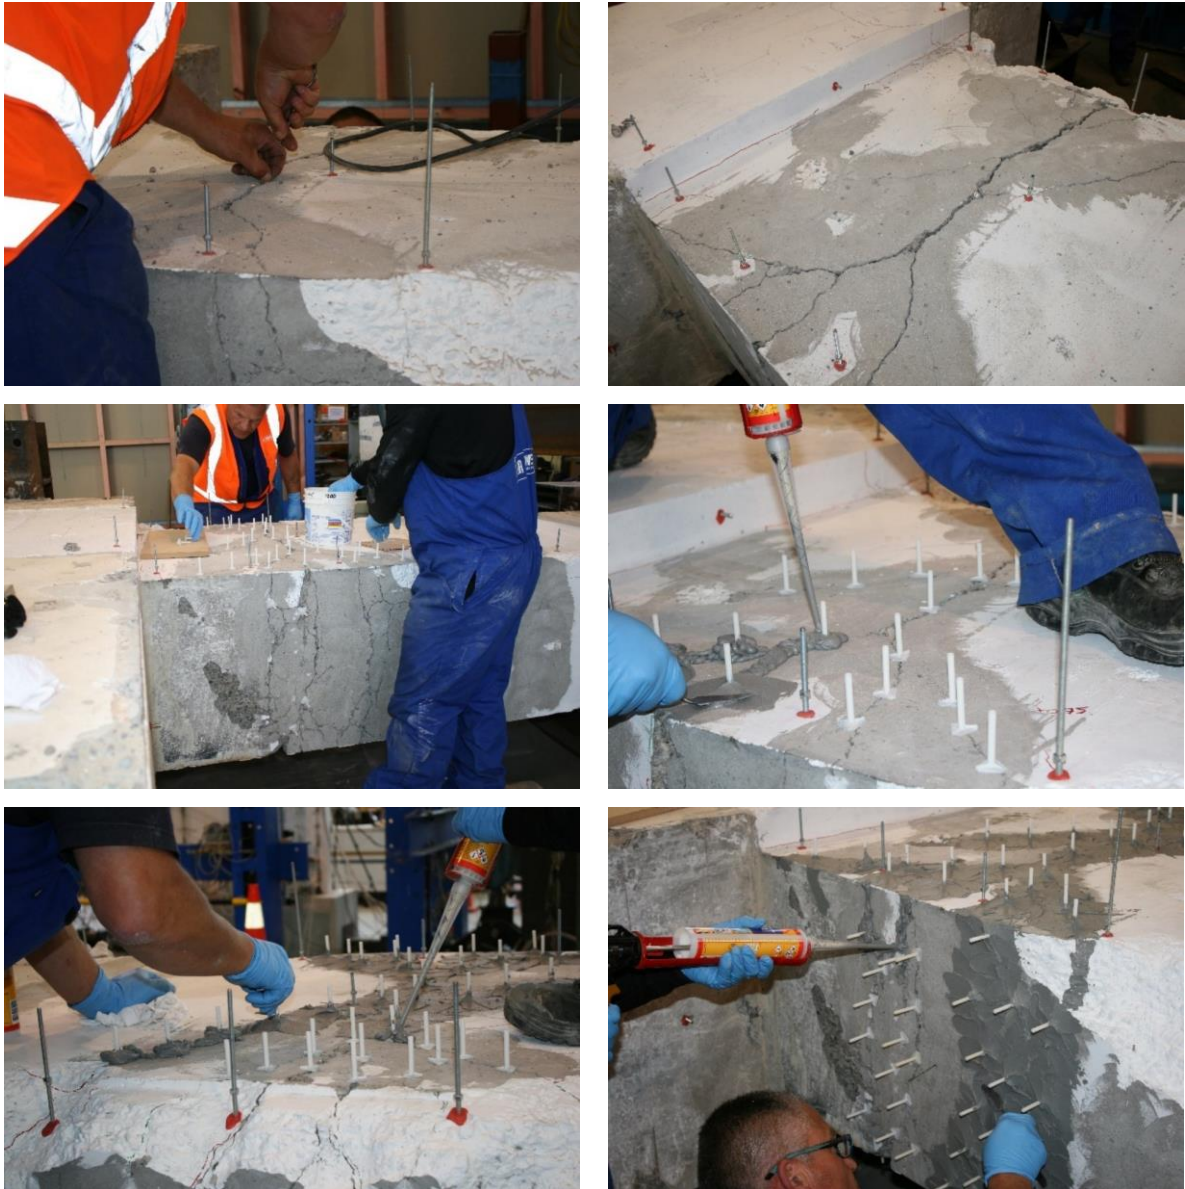
Figure D- 1. Sealing of the cracks before the epoxy injection, Test 3.

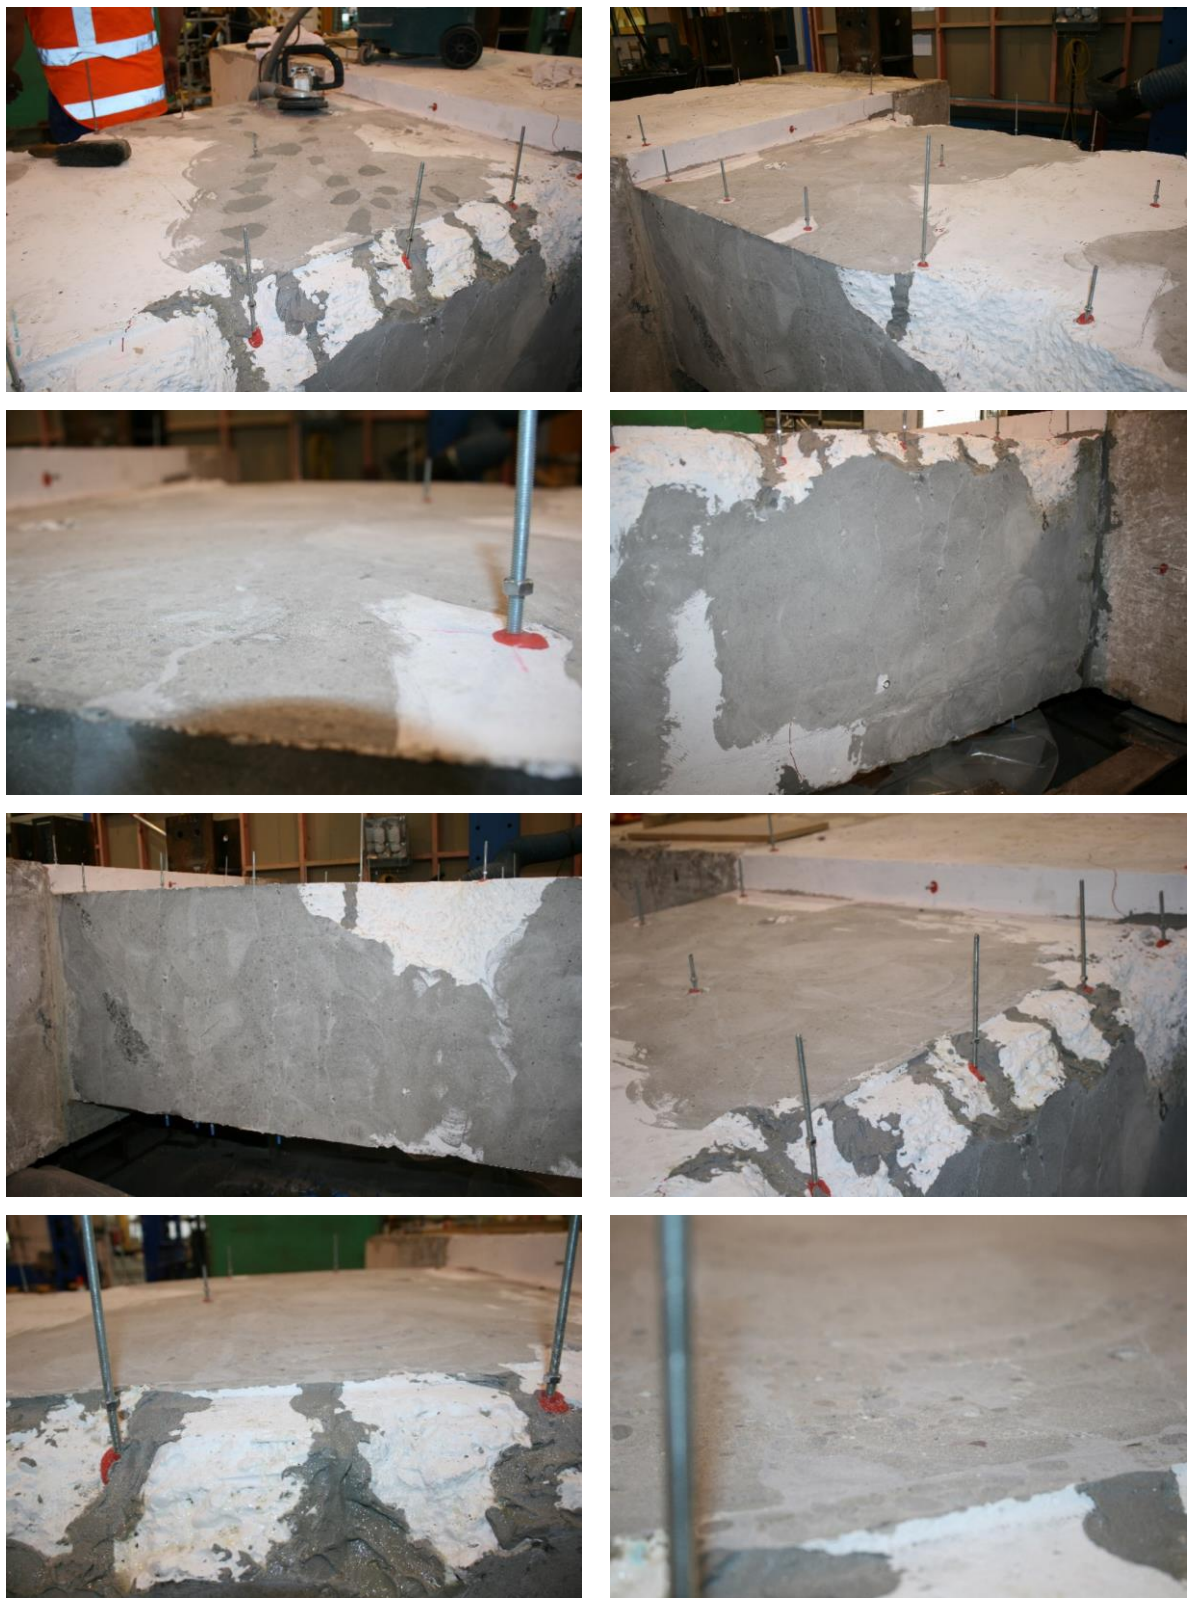
Figure D- 3. Cleaning process after the epoxy has cured, Test 3.
